## Zebra mussels clog up city golf course's irrigation system

By **Brad Johnson**,  
for the Watertown Current

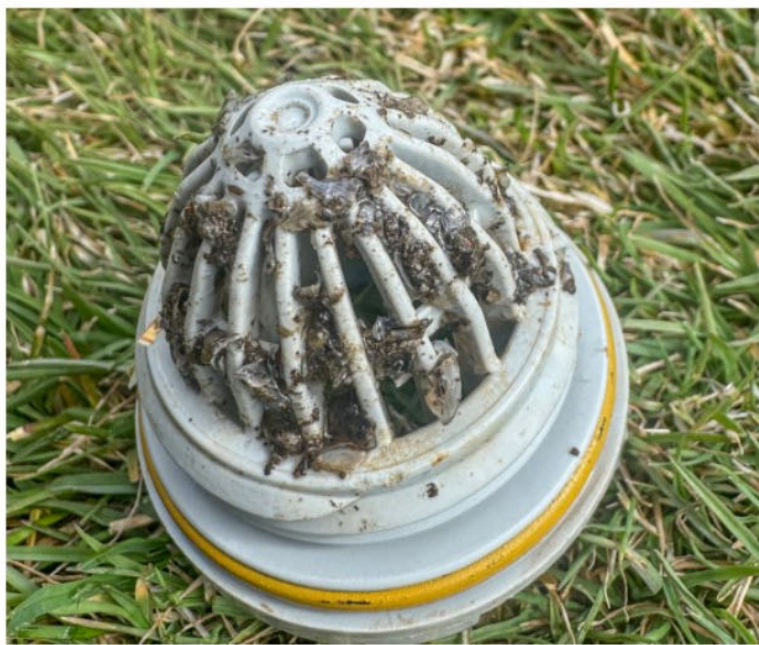
After crews dug a two-foot hole to remove a sprinkler head it was found to be jammed with zebra mussel shells.

"My concern is that every sprinkler head is on a swing joint," Schunter said. "The first swing joint was packed full, which means we have to dig up the entire head."

**Many sprinkler heads at Cattail Crossing Golf Course in Watertown were found to be infested with zebra mussels, causing some major problems for the course's irrigation system. Photos by Scott Schunter, Cattail Crossing Golf Course.**

An investigation into remedies "is just beginning," he said, noting that different chemical treatments are possible. That includes "the use of an acid injector" to inject a "food grade acid into the system to change Ph in the water below 6.9, a stage at which the larvae won't grow."

Still others require specialized flushing in the fall, mechanical removal and replacing components with new ones made of copper, brass or galvanized metal, all of which can be toxic to zebra mussels.
